Cormorant Roosting in Offshore Wind Farms

An investigation into bird behaviour, conflicts, and mitigation measures at Burbo Bank.

Report 1: Initial Scoping Investigation
11th February 2021

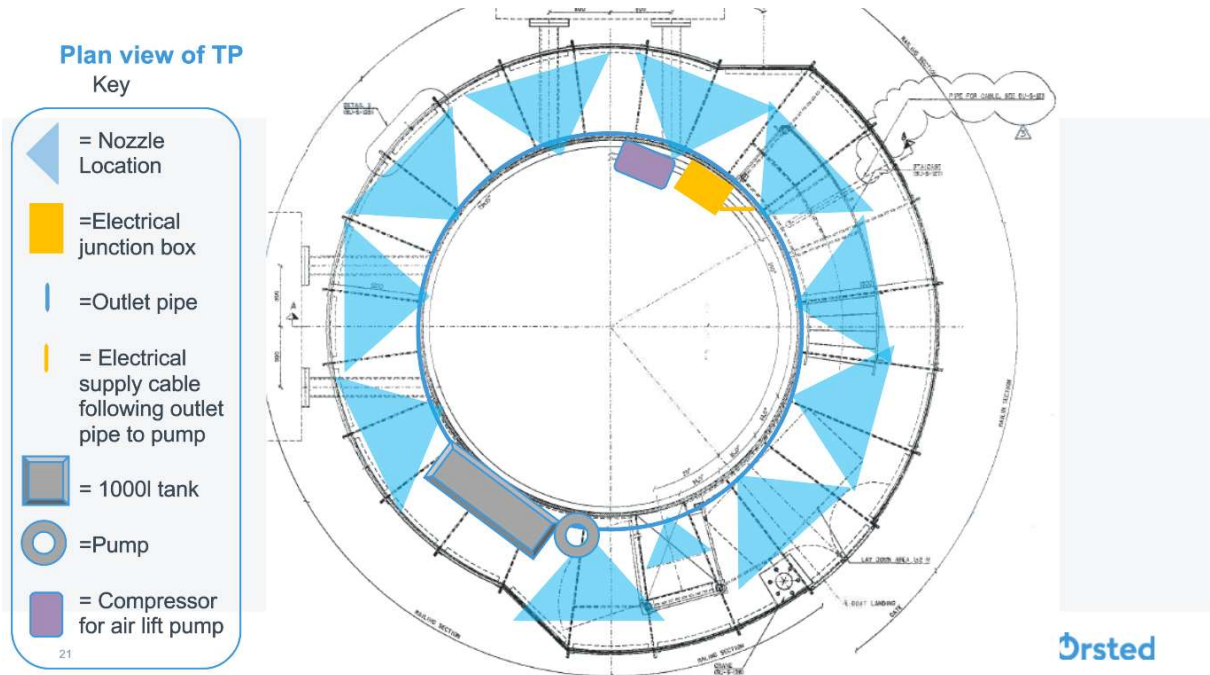
Figure 8: Diagram of TP Clean Assist design, shown in plan view with key components and spray area marked. Kindly provided by James Almond, Ørsted.

An automated cleaning device, named 'TP Clean Assist' or 'Clean Assist' for short, has been partially designed and trialed by one of the technicians on site. This involves a pump and spray nozzles which are timed to spray sea water over the transition piece for approximately one hour per day. Figure 8 and Figure 9 show the design of this system, with the key components labelled.

A control system has been developed for this TP Clean Assist, which will allow for cleaning every night during the high tide, however some assistance is needed with mechanical design, due to concerns about mounting, stability, pump capacity and the number of potentially breakable parts. This is an area for which wider support may be needed, as the technician in question has very limited time to spend on this project.

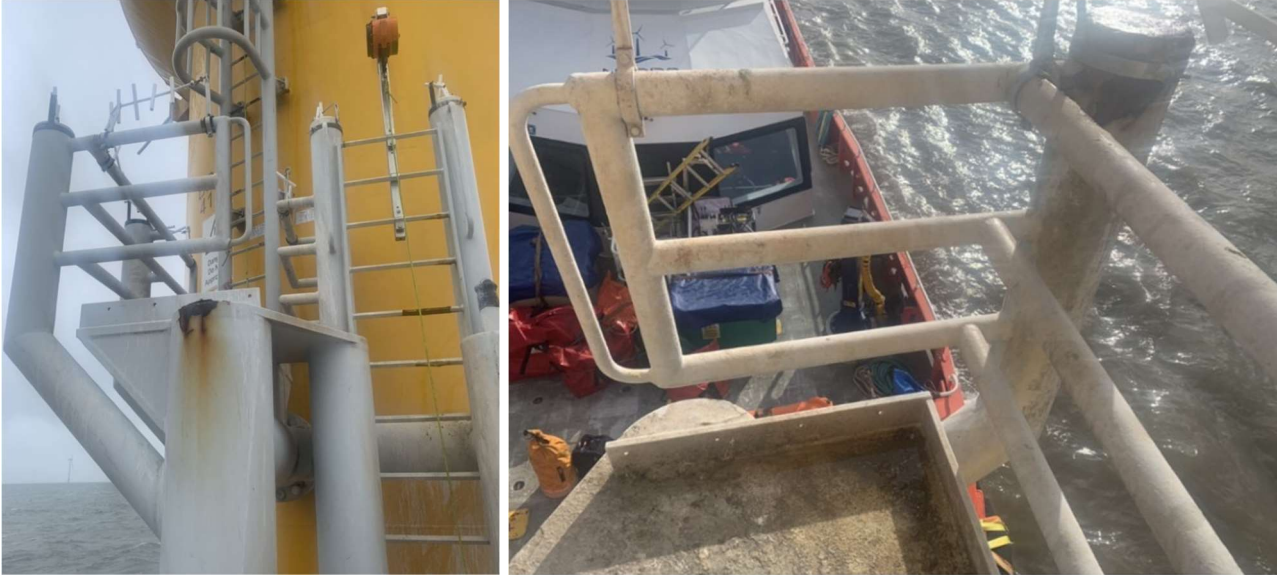
Figure 11: Photos of corrosion at Burbo Bank offshore wind farm (kindly provided by James Almond, Ørsted).

While the Burbo Bank technicians were not aware of any corrosion issues arising from the guano, several studies have shown that bird guano can degrade the coating systems via chemical mechanisms, mainly due to hydrolytic reactions from a catalytic effect of the enzymatic structure of guano or pancreatin. Such degradation can lead to conditions that allow corrosion to initiate earlier than expected (Price and Figueira, 2017). Appendix C shows corrosion occurring at Burbo Bank, thus, it cannot be ruled out that guano is not causing enhanced corrosion, however as none of the interviewees reported this, it's unlikely to be occurring to an extent that warrants any major concerns.
